ATTENTION: ALL STEPHENS-TYPE MONOPLANE PILOTS

By Kermit Weeks
Photos by John Ford

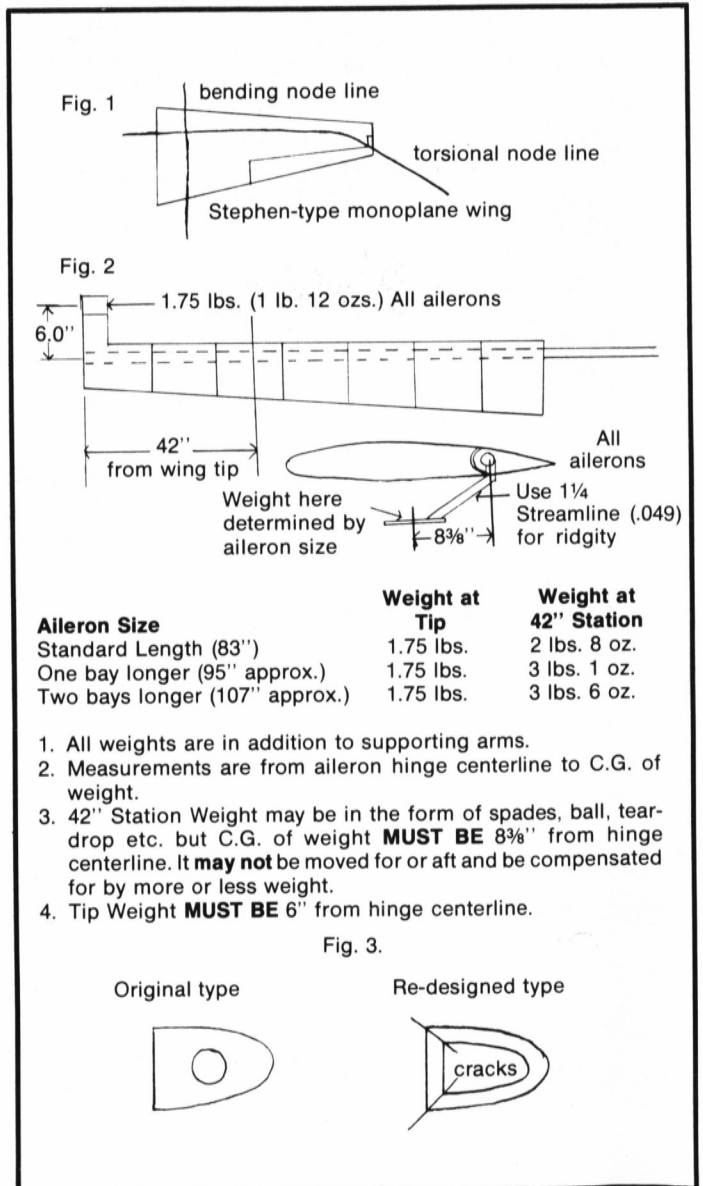
Within five minutes of shaking the wing, Leon said that we had a problem. For proper flutter dampening the aileron counterweight had to fall outside the bending mode node lines and behind the torsional mode node lines. The torsional mode node lines on both airplanes tested fell behind the balance weight at the tip (Fig. 1). The bending mode node lines were obviously well inside the tip counterweight and were not a factor.

has agreed to write an article at a later date that would explain the concepts of flutter and how they relate to us. For now he states that the "aileron was not adequately dynamically balanced to preclude flutter in a wing torsional aileron-rotation mode. The aileron was statically balanced but was not adequately dynamically balanced." He also feels that "the wing is not tied into the fuselage as good as it should be." While not a structural problem, the wing would have a higher frequency (hence higher flutter speed) if it were more securely attached.

Apparently, early in the design, the nose-ribs were constructed with a single hole cut out of the plywood for lightning. Later, after a redesign, a larger cut-out was noted in the plans, following the same shape as the nose section (Fig. 3). Henry's ribs were all cracked in the corners as shown. Jerry's ribs were of the same construction and may have contributed to the accident. As the rigidity of the wing is lost, the speed at which it will flutter will be lower.

After several weeks of sorting out his data and running computer programs, Leon came up with the attached data (Fig. 2). Realizing the difference in certain aileron sizes, several weights are given for a particular aileron case. Unless you plan to red-line your Stephens-type monoplane below 160 mph, this is a MANDATORY modification!

Basically all ailerons should be balanced with 1.75 lbs. at the tip and with a "spade" type balance 42" in from the tip. This inboard weight will depend on the size of your aileron but **must** be located 8 3/8" from the hinge centerline. Conforming to these changes should give your aircraft a flutter speed in excess of 300 mph.

I would strongly suggest to anyone with a Stephens-type monoplane to determine what type of rib construction your wing has and make sure that it is properly designed. While not a flutter consideration, Leon suggested that the span-wise stringers are of good design technique and should be installed during construction or re-skinning. In talking with Leo Loudenslager, he stated that he had the original nose-rib design and stringers installed. With over 700 hrs. on his wing he has had no apparent leading edge problems.
