ATTENTION: ALL STEPHENS-TYPE MONOPLANE PILOTS

By Kermit Weeks
Photos by John Ford

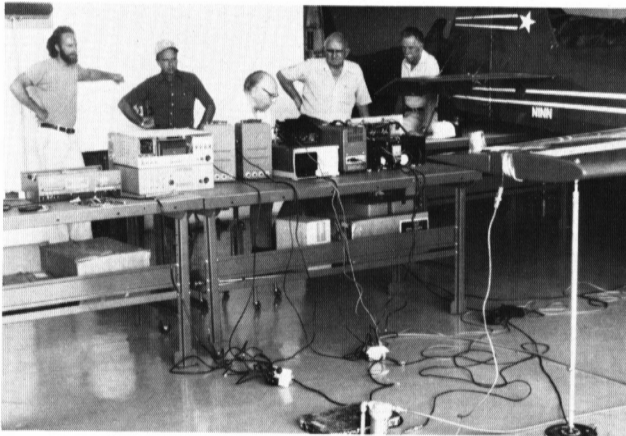
Leon setting up his equipment. Note: the shaker on the floor and accelerometer in place on wing.

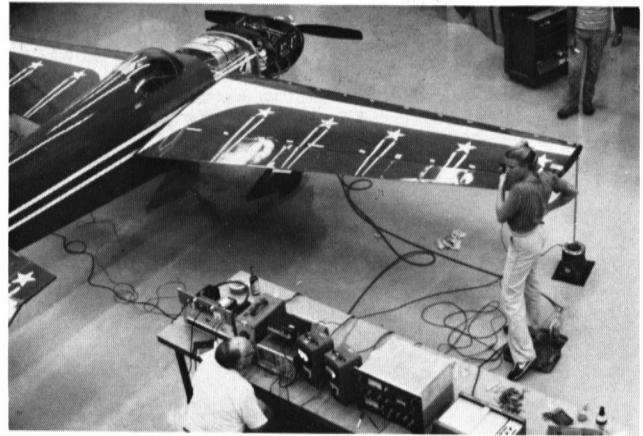
Testing in progress with cowling and fairings removed for wing freedom. Note: the tape locations on the wing where accelerometer was placed for different readings.

Within five minutes of shaking the wing, Leon said that we had a problem. For proper flutter dampening the aileron counterweight had to fall outside the bending mode node lines and behind the torsional mode node lines. The torsional mode node lines on both airplanes tested fell behind the balance weight at the tip (Fig. 1). The bending mode node lines were obviously well inside the tip counterweight and were not a factor.
